# Situation Photo Log

Thursday, March 1, 2012

Kalamazoo River / Enbridge Spill

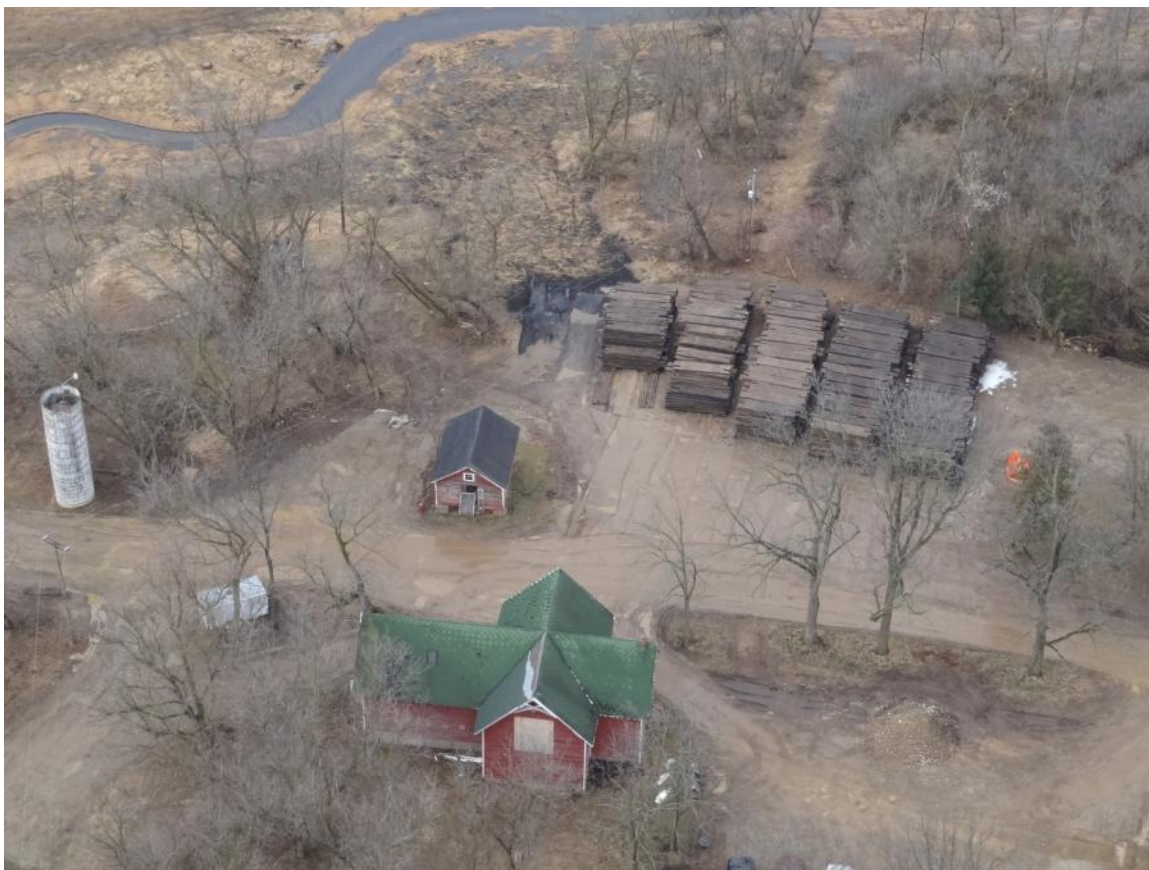
1. Timber Mats being staged off Division Street.

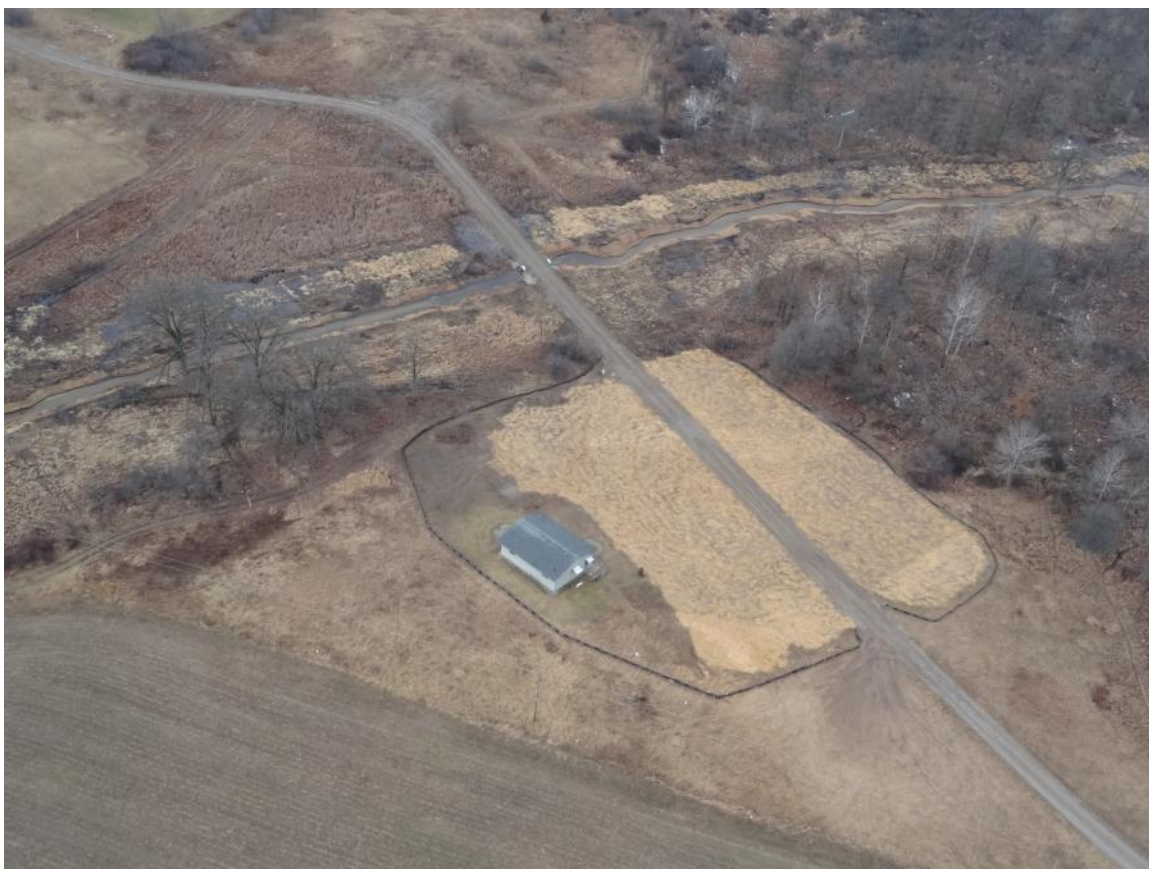
2. Talmadge Creek Staging area near MP0.75 observed area was demobilized and restored.

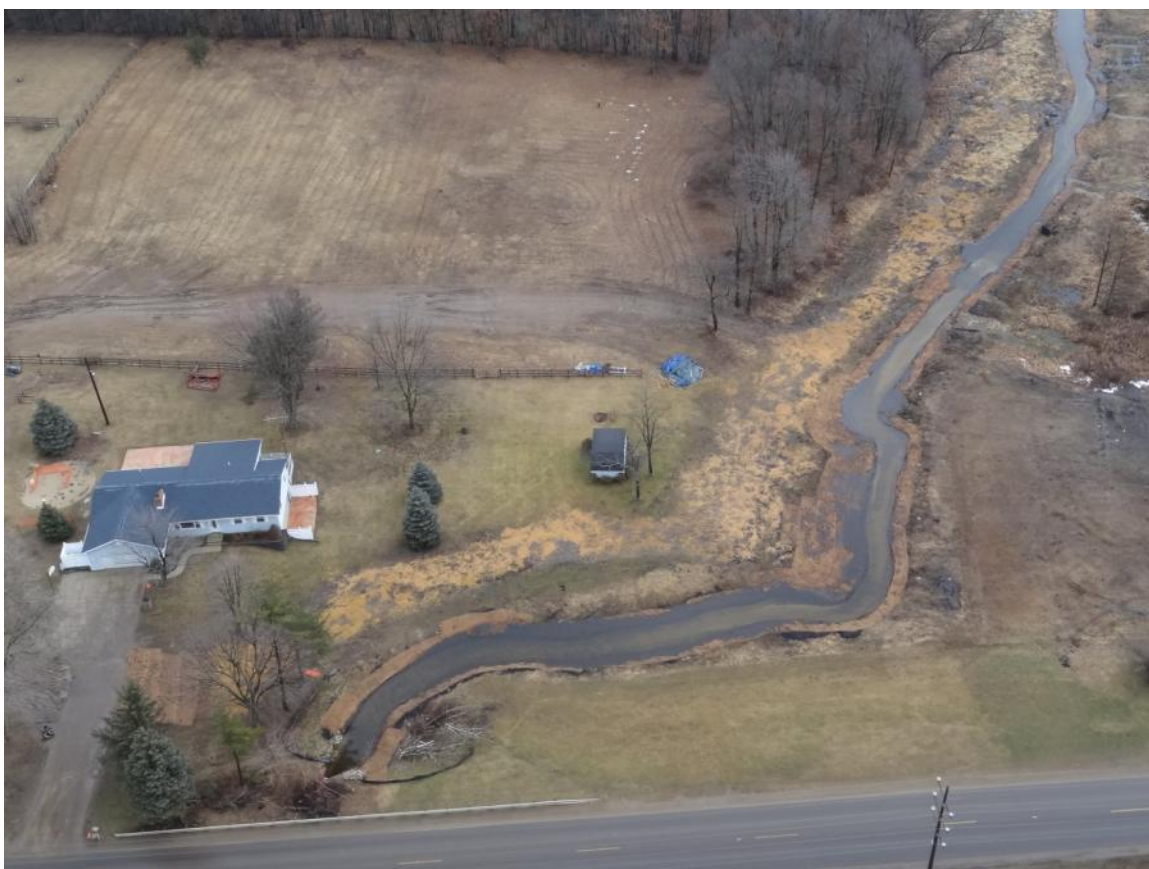
3. Timber mat road removed and restoration work observed near MP1.1 along Talmadge Creek.

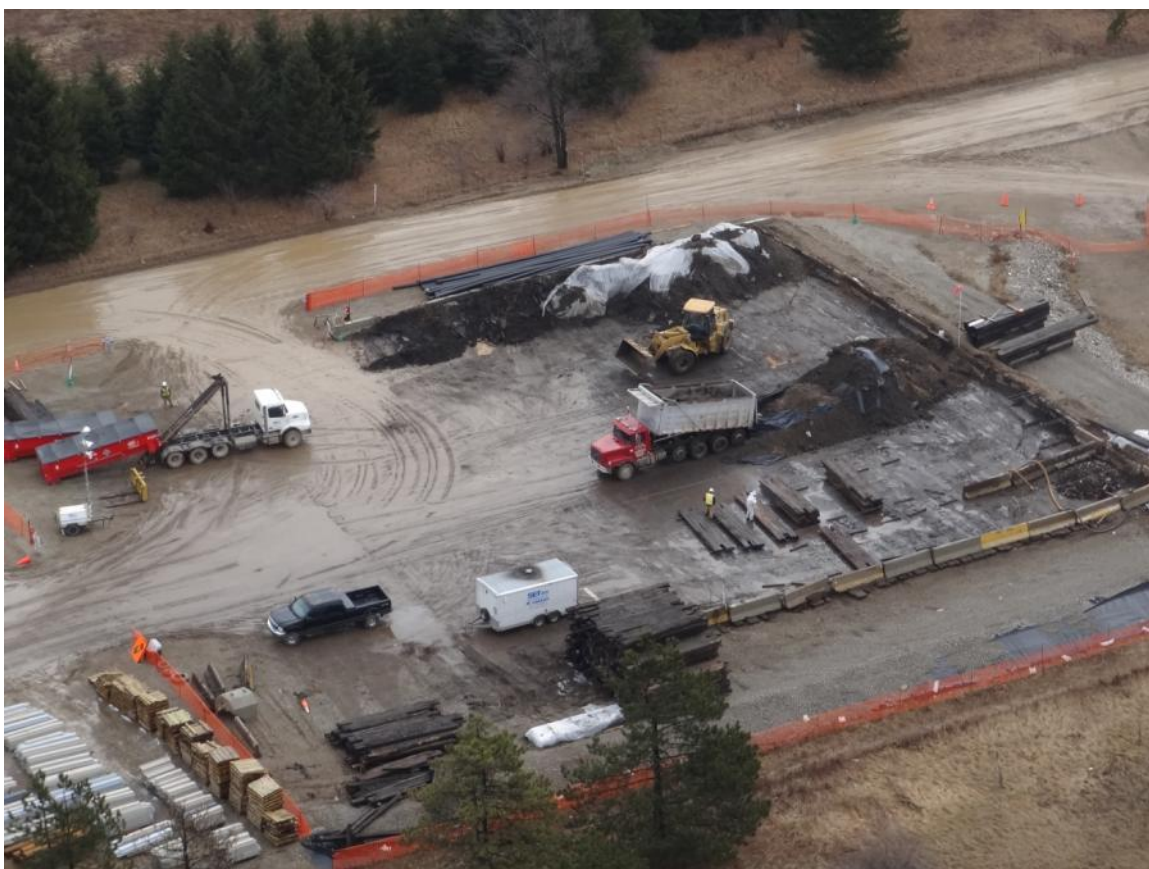
4. Frac-City Soil Cells A & B.

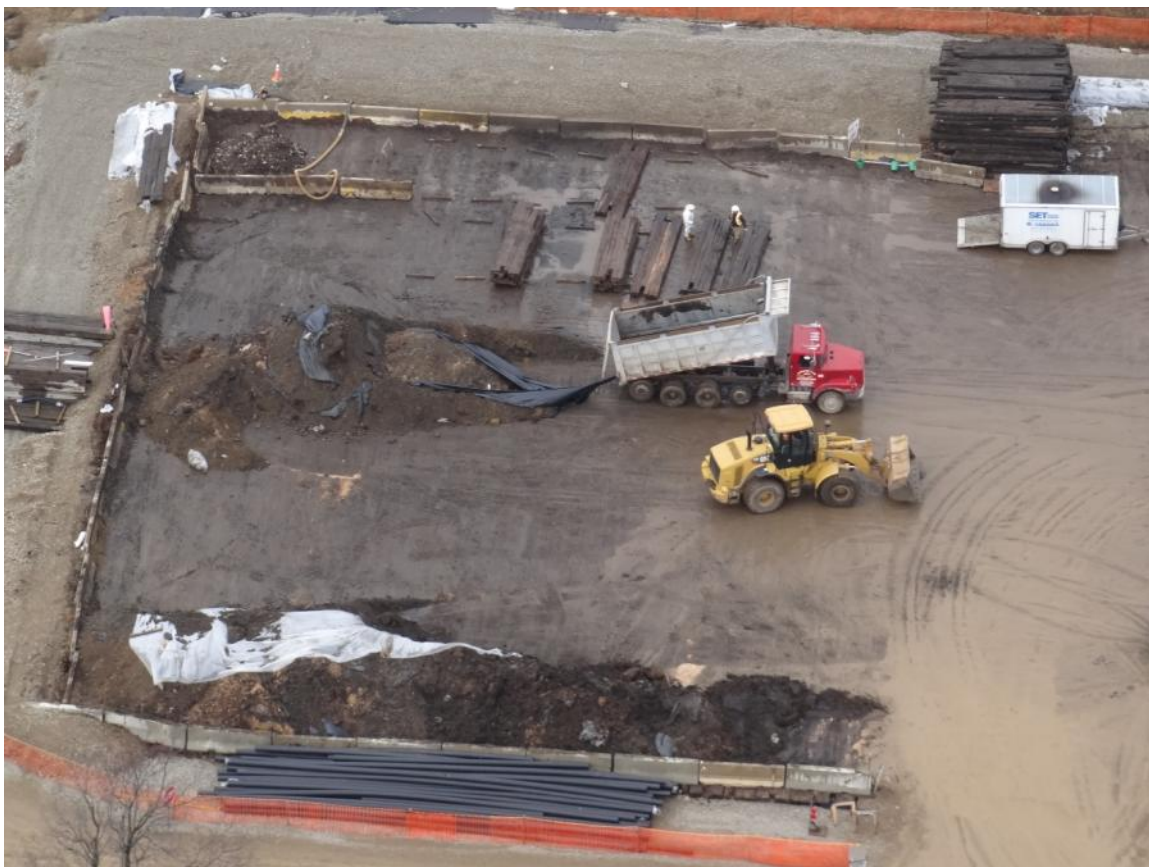
5. Frac-City Soil Cells A & B.

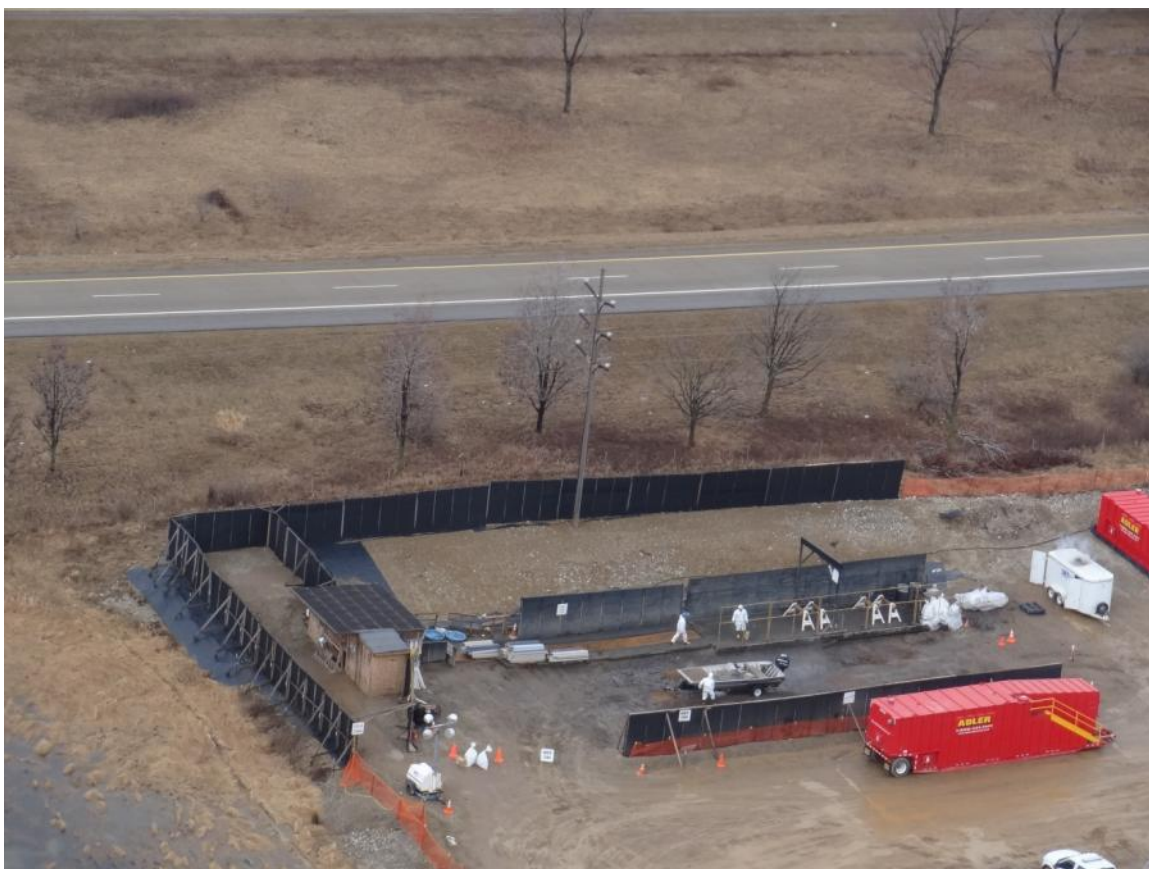
6. Frac-City observed a Jon Boat being decontaminated.

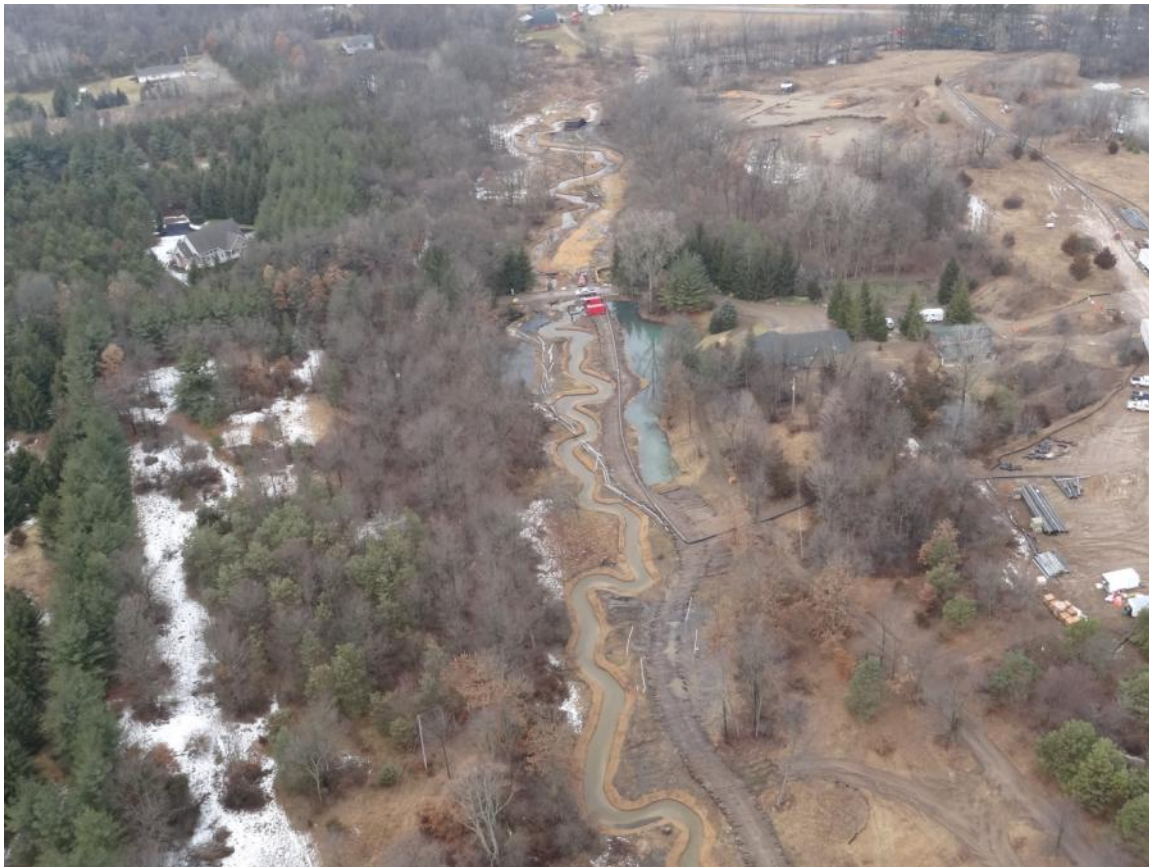
**7. Talmadge Creek near MP1.75 timber mats removed and restoration work observed.**

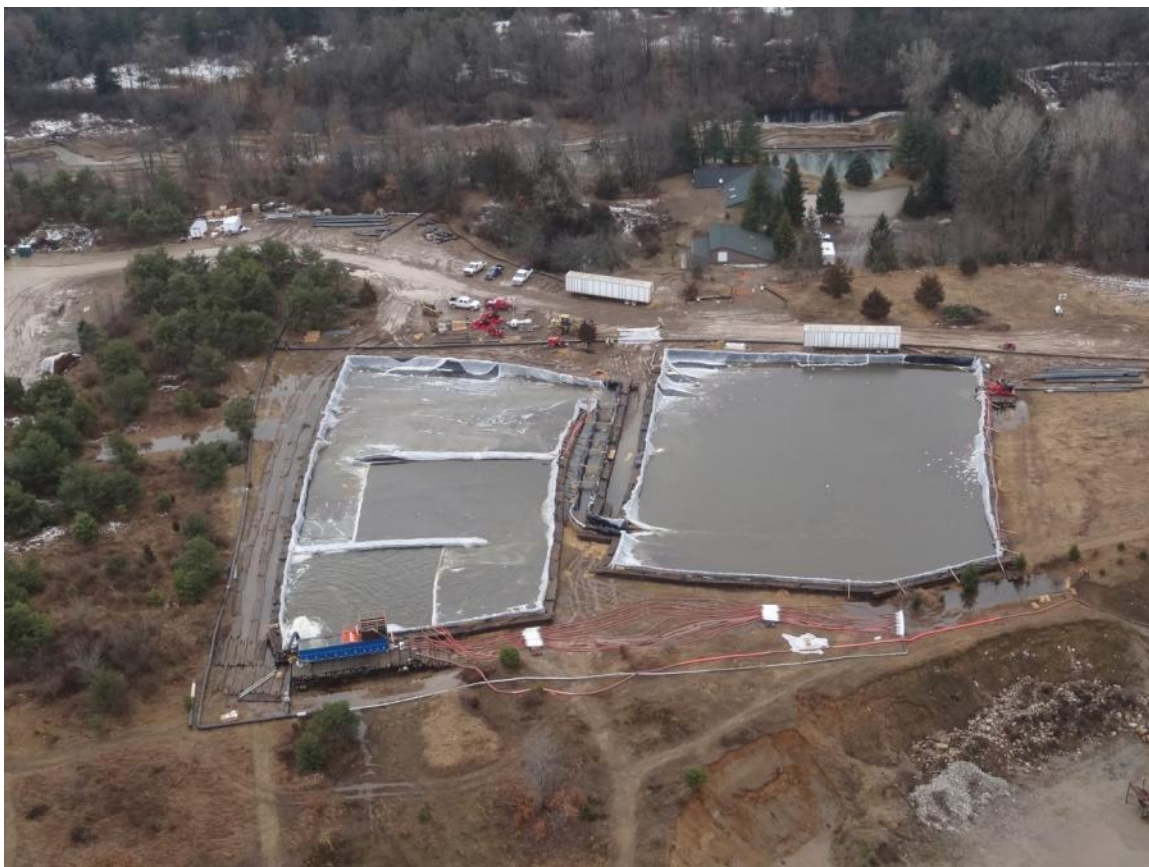
**8. Talmadge Creek turbidity control structure.**

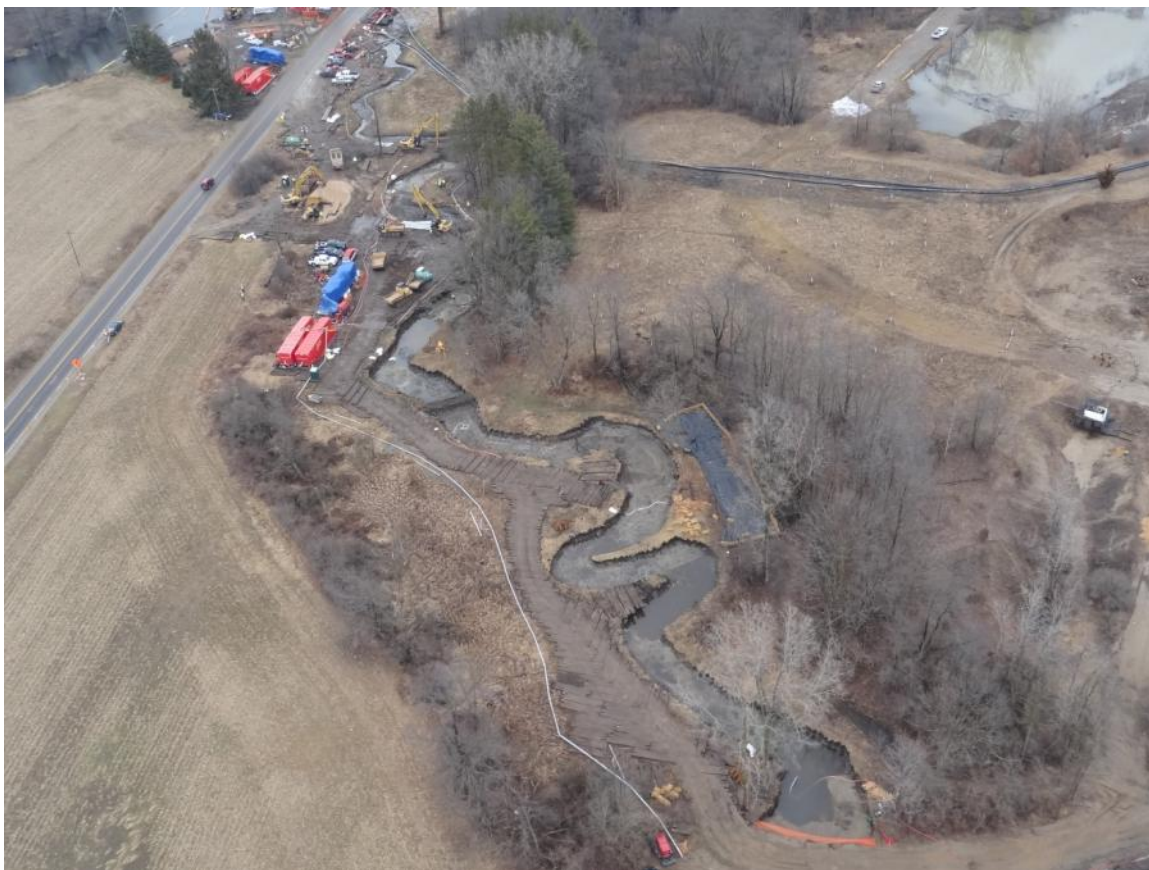
9. Overview of Talmadge Creek work.

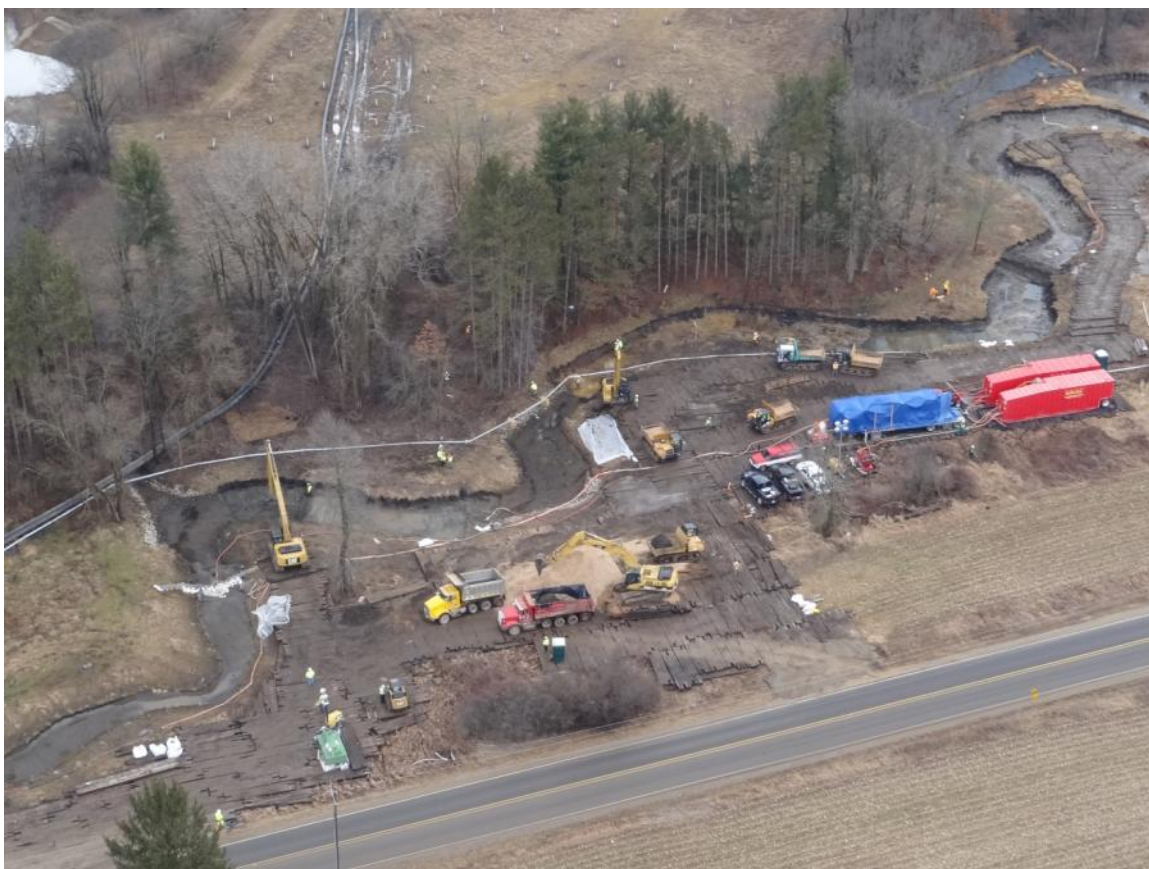
10. Talmadge Creek near MP1.9 excavation work observed.

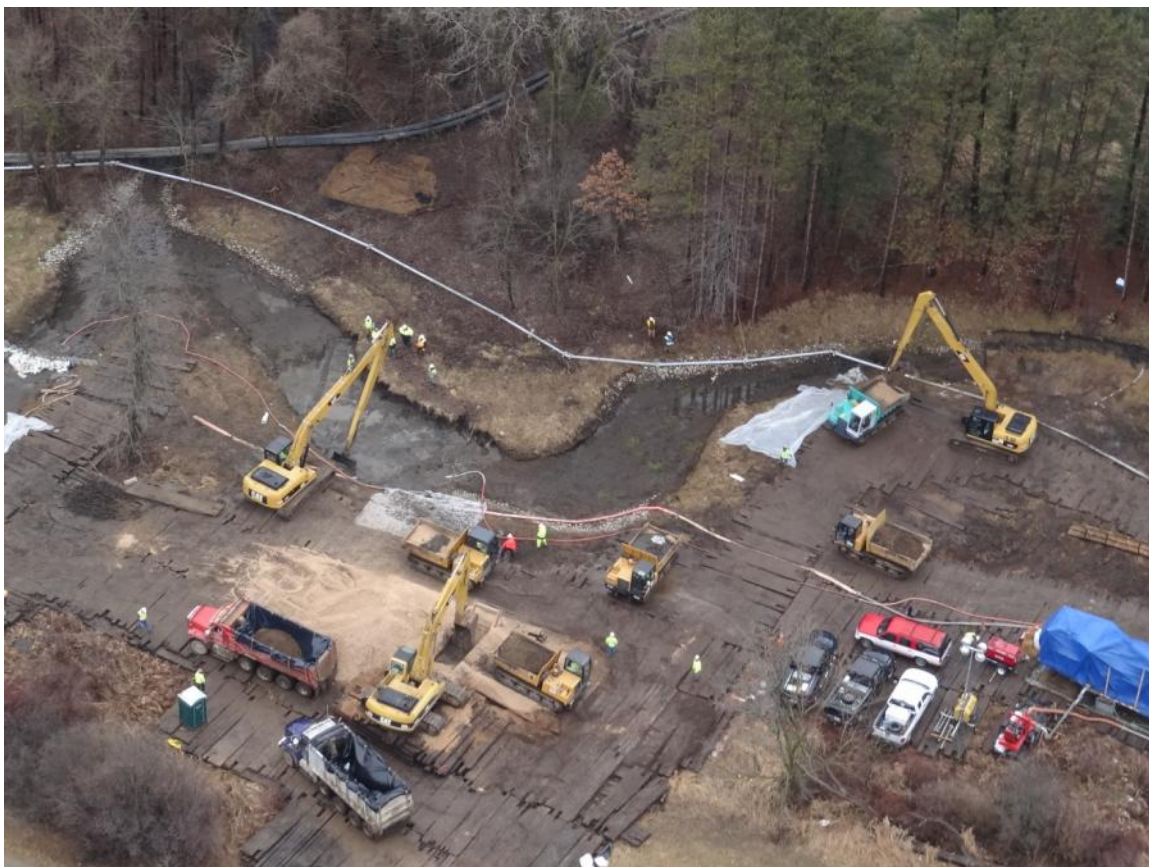
11. Talmadge Creek near MP1.9 excavation work observed.

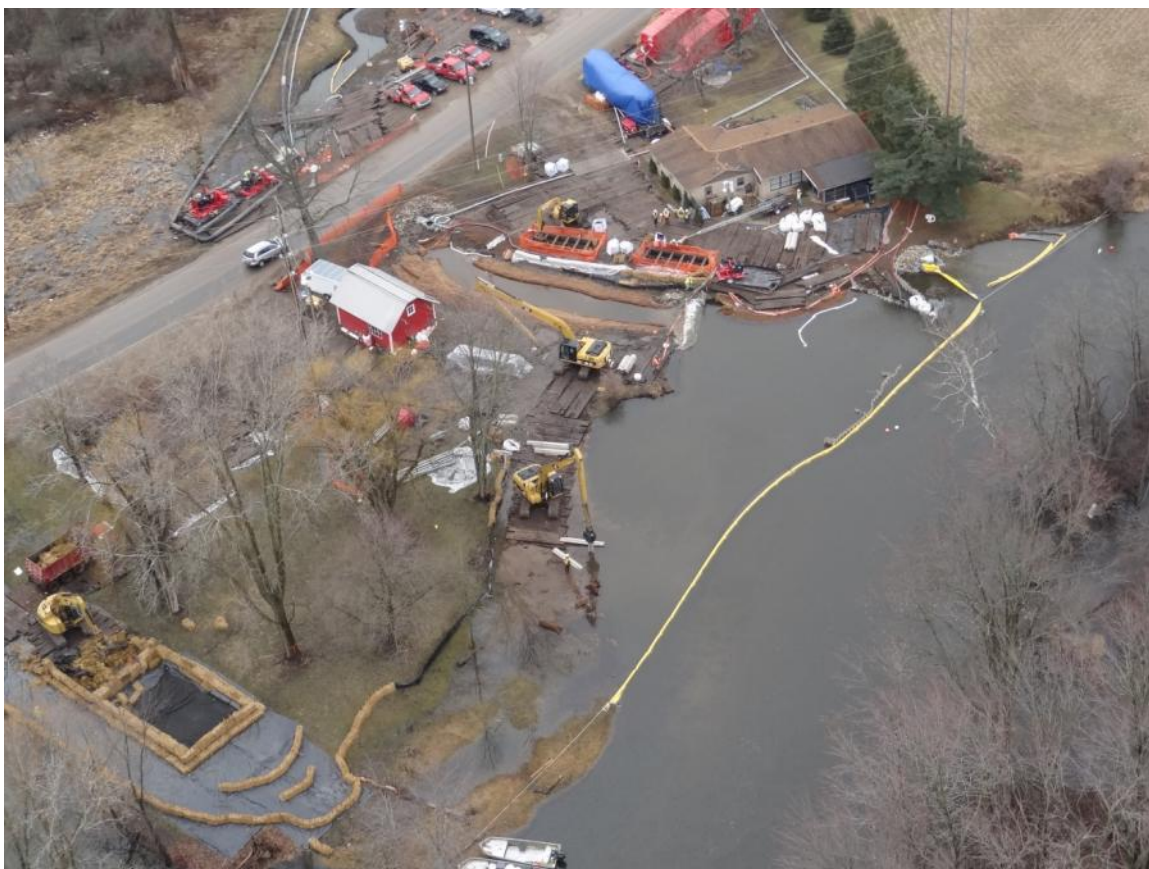
12. Overview of Confluence work.

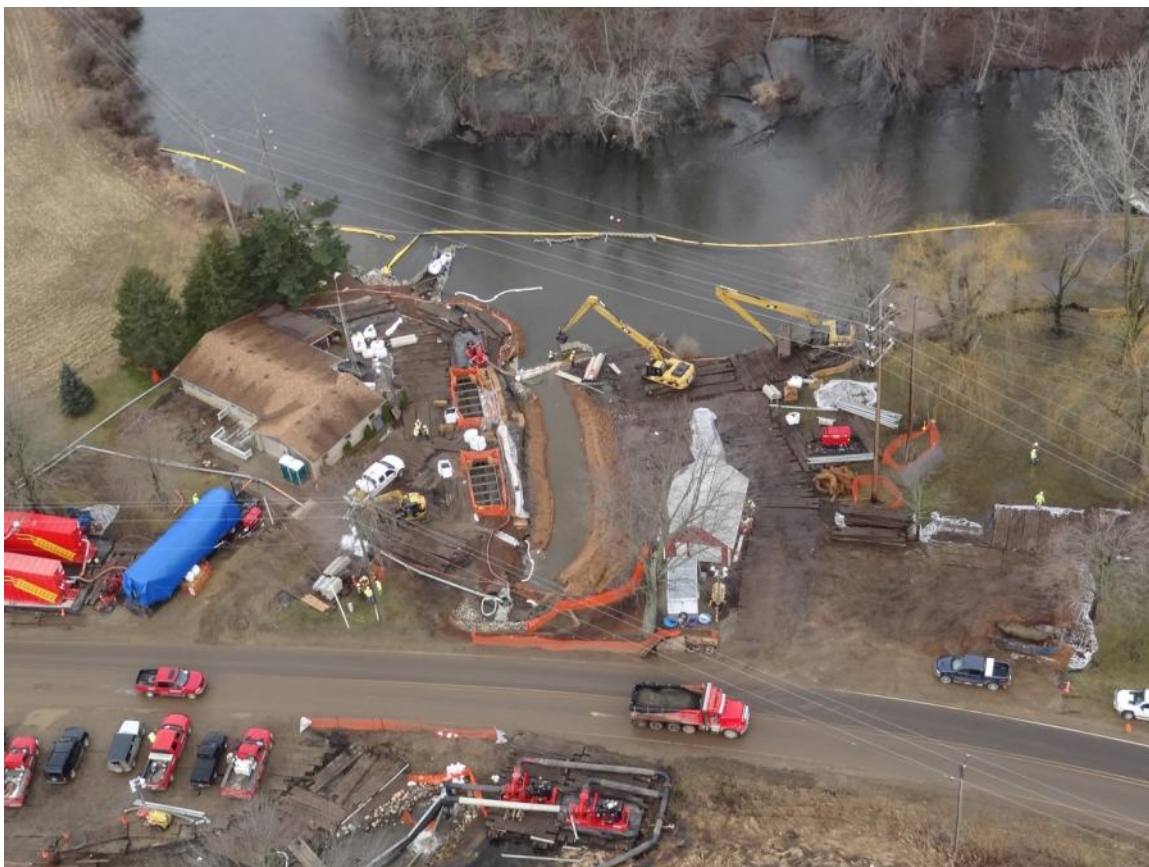
13. Overview of Confluence work.

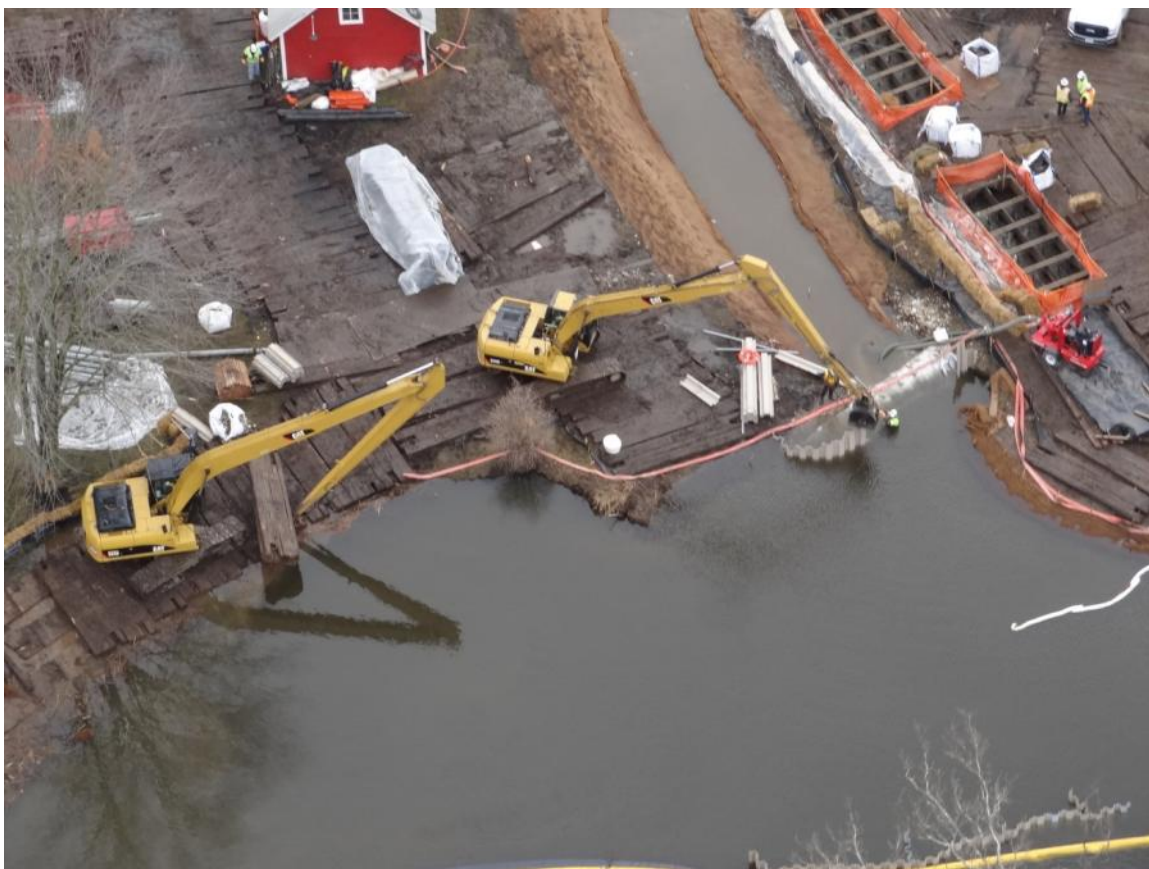
14. Overview of Confluence work.

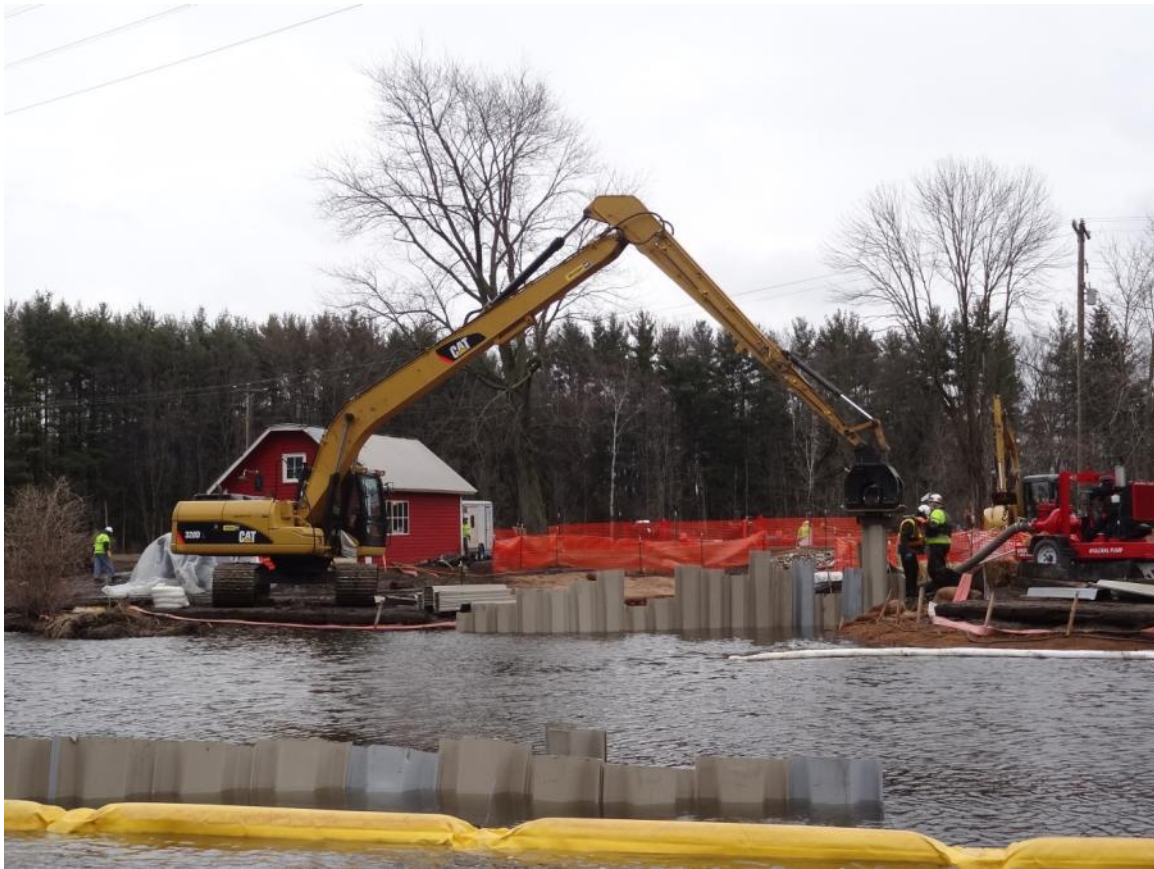
15. Overview of Confluence work, observed sheet piling being installed.

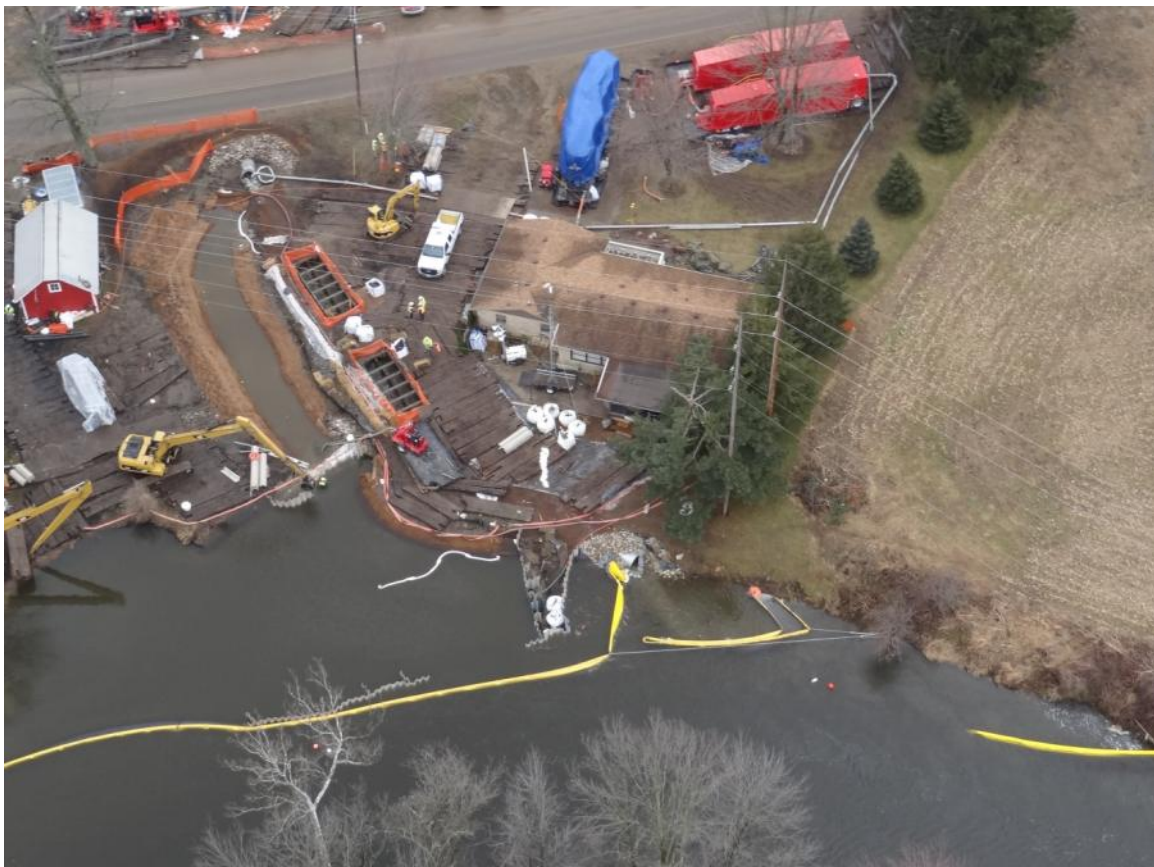
16. Overview of Confluence work.

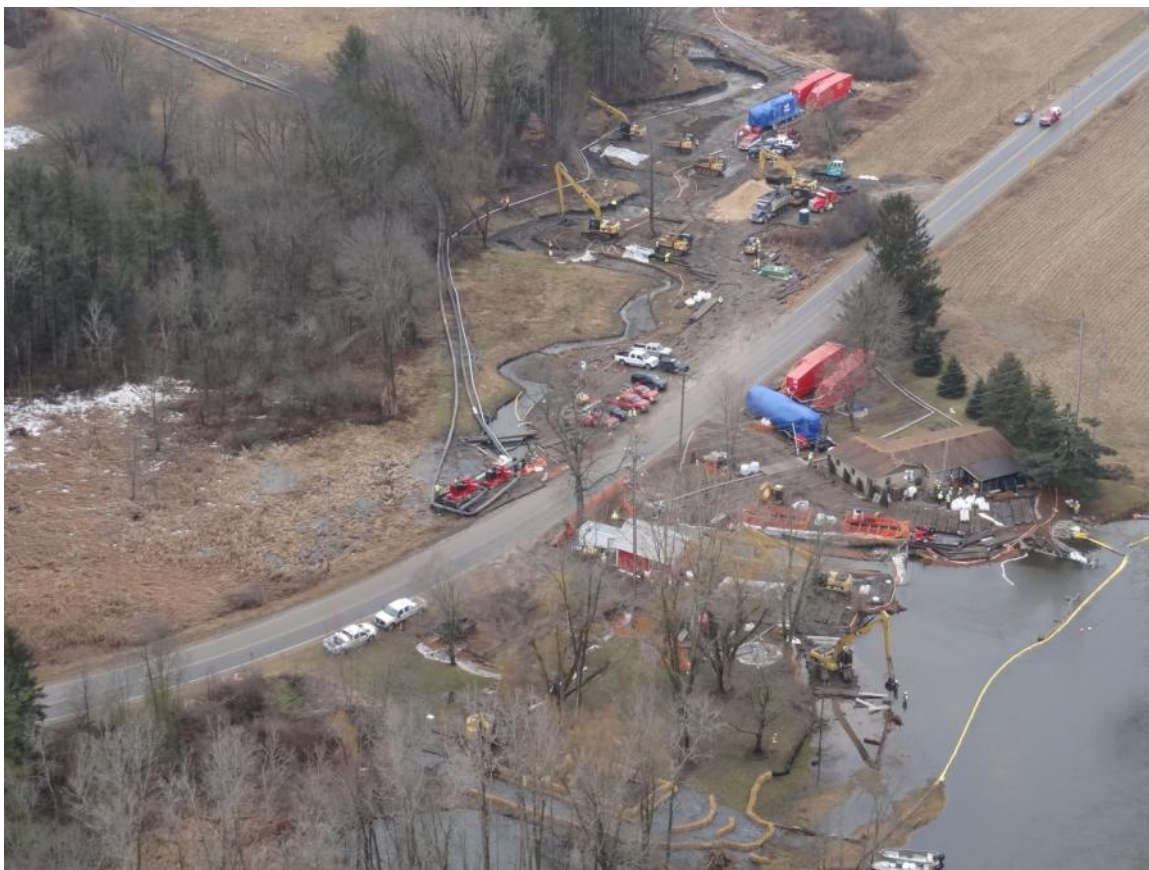
**17. Overview of Confluence work.**

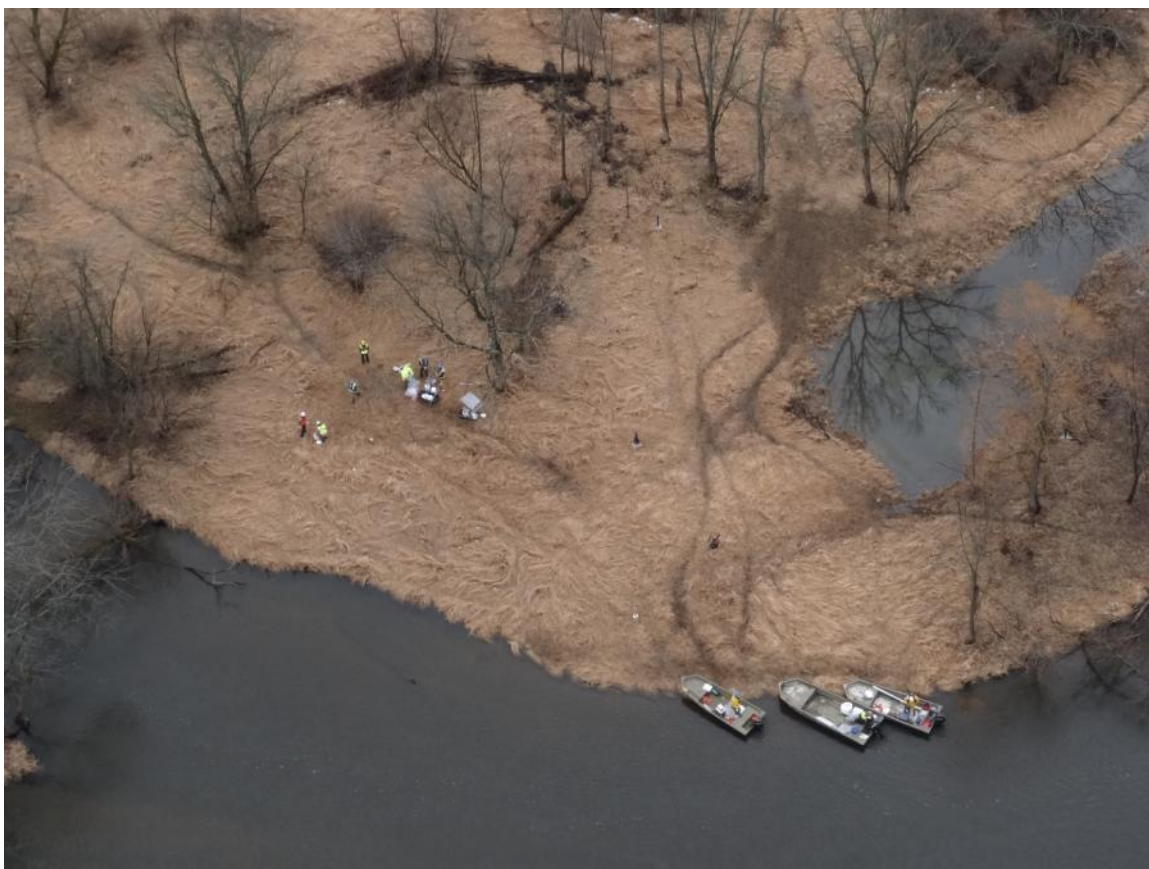
**18. MP2.75 RI crew observed.**

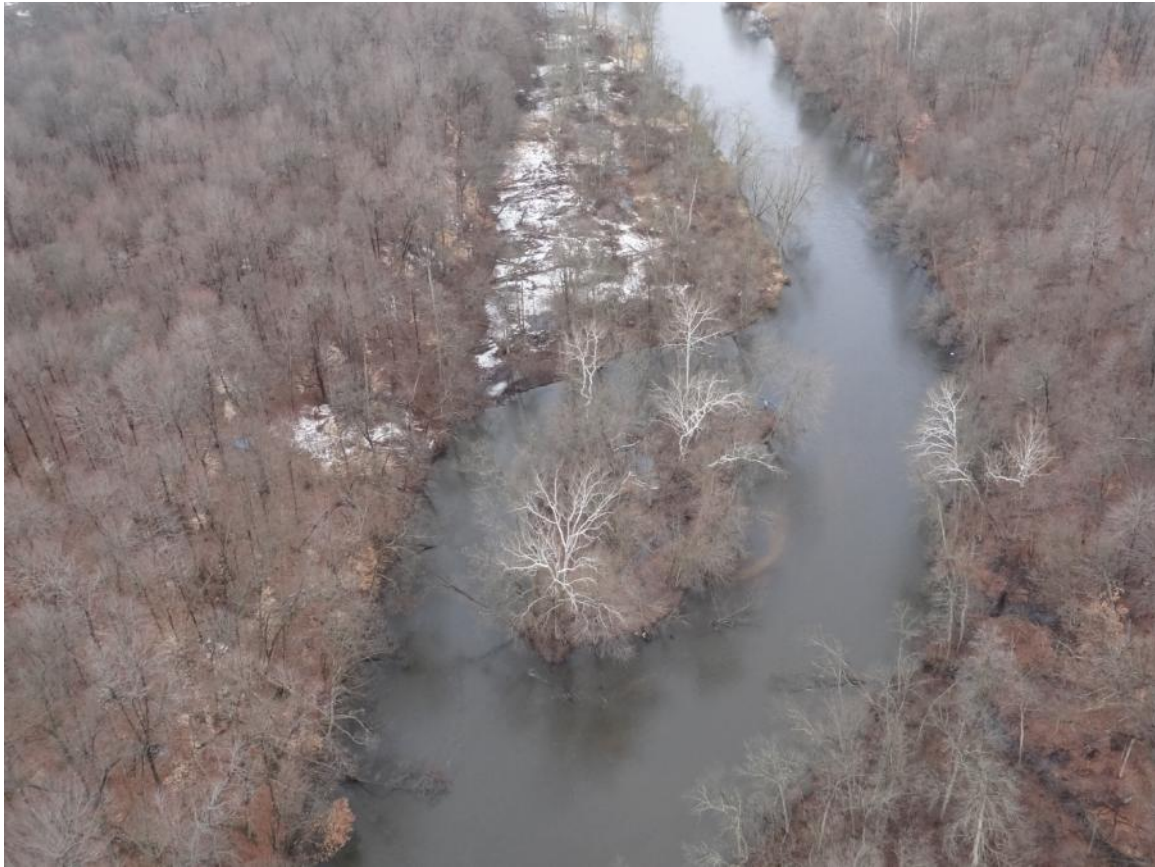
19. OB8.97 I and OB9.10 LDB scrape locations.

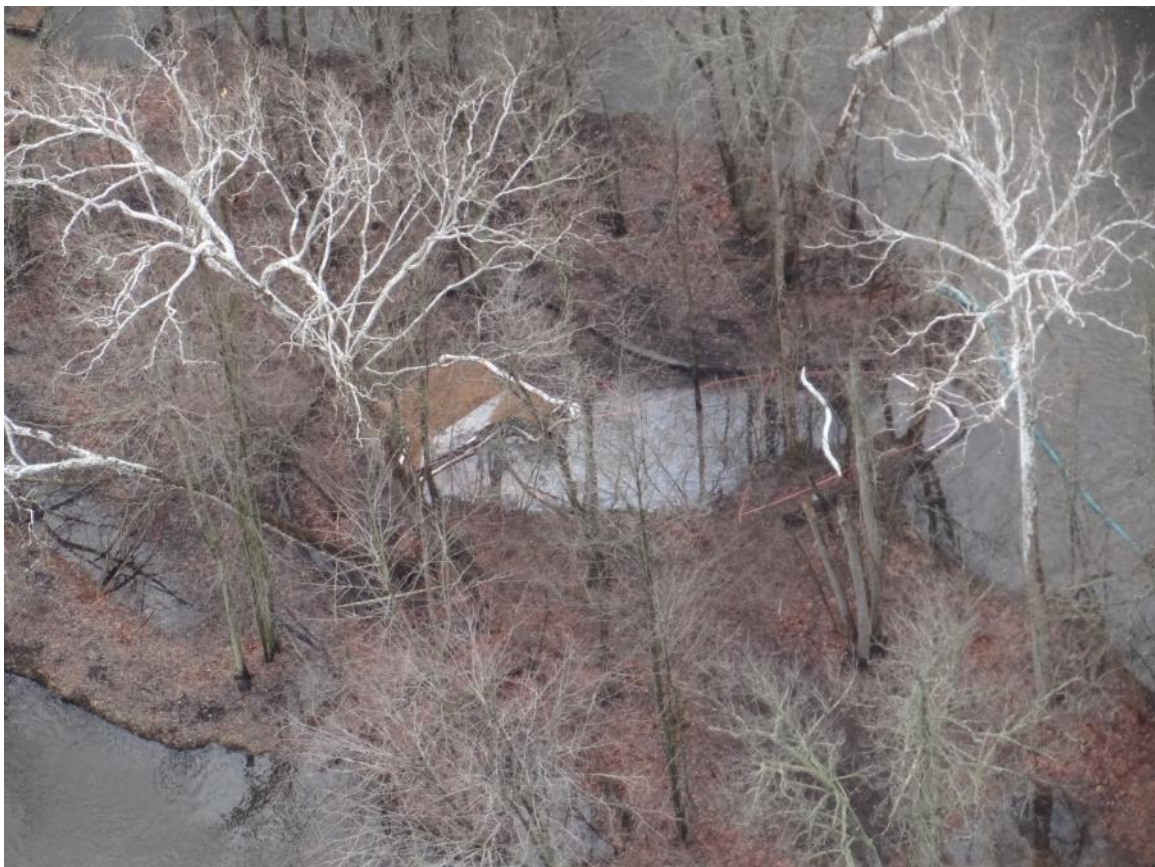
20. OB8.97I sheen observed in scraped area.

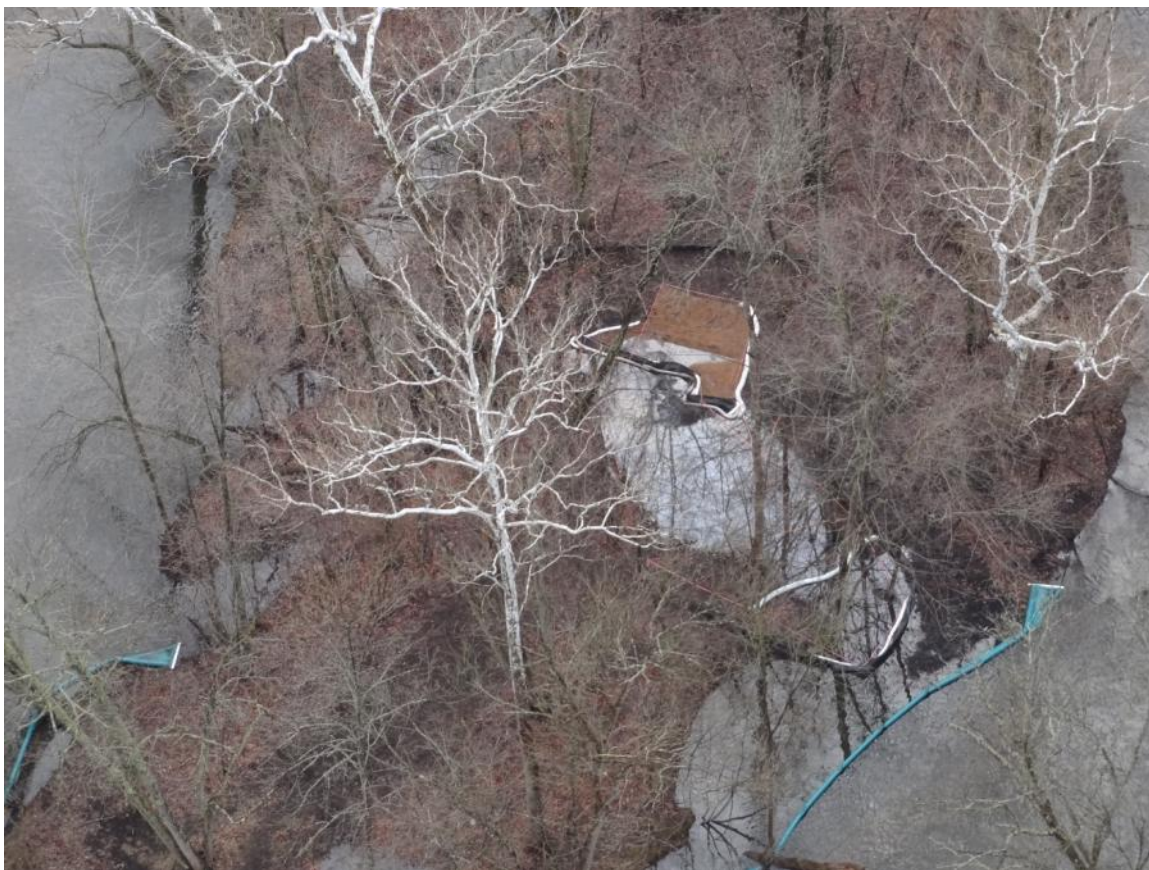
21. OB8.97I sheen observed in scraped area.

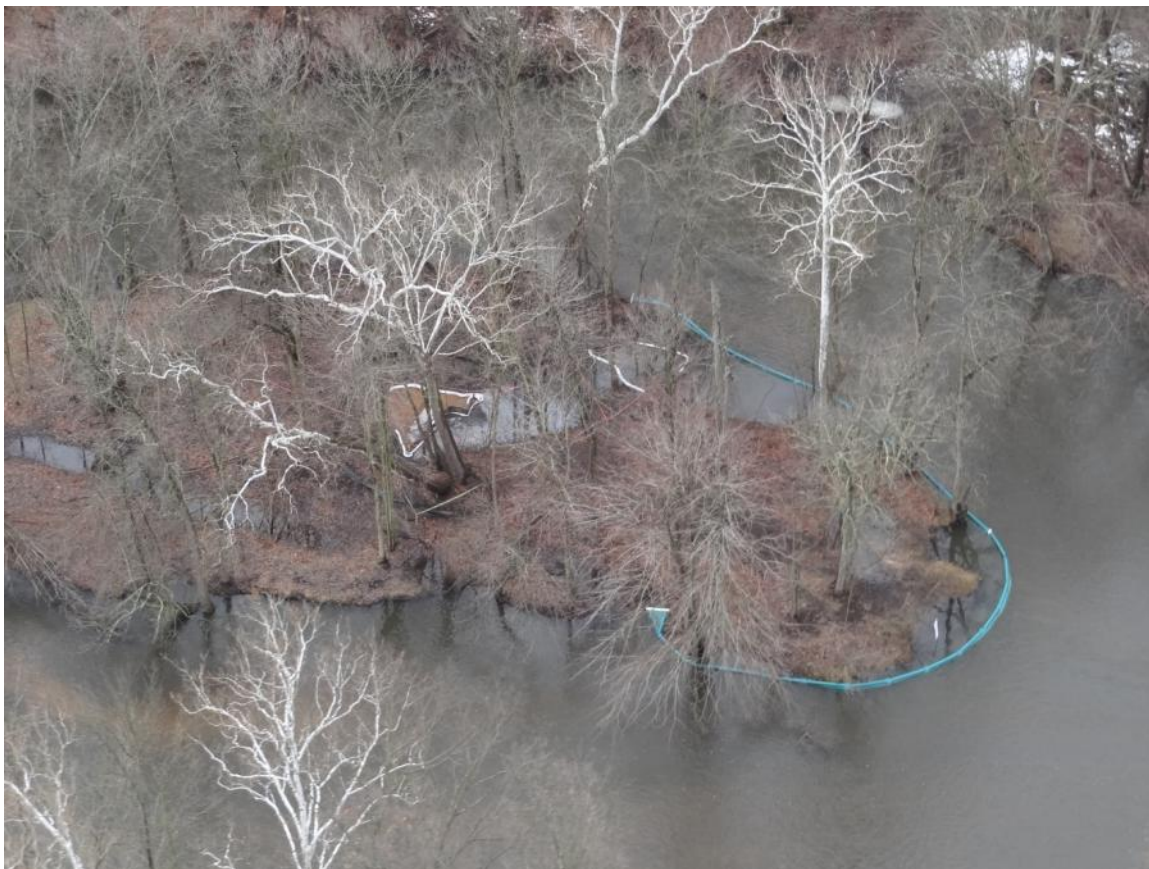
22. OB8.97I sheen observed in scraped area.

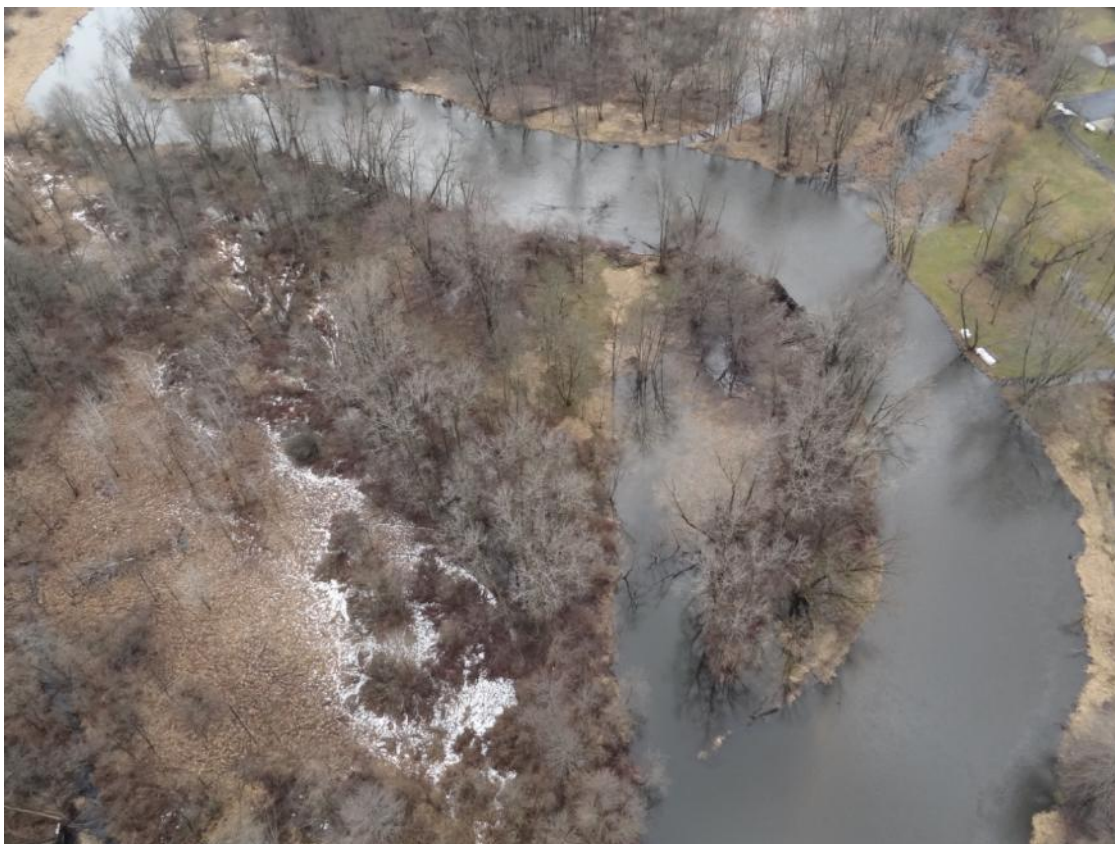
**23. OB10.37 RDB scrape location.**
